F00RJ01895 Injector Valve Assembly Technical File SPATERIC and a

Shenzhen Shumatt Technology Co., Ltd F00RJ01895 Injector Valve Assembly Technical File

1. F00RJ01895 Injector Valve Assembly's Introduction

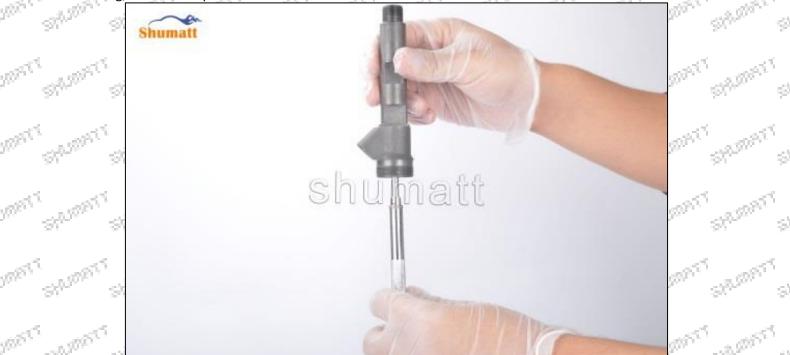
SPATISTICS STATES (1) Use special installation tools - the sealing ring and support ring in CRT029 to put them into the injector housing, as shown in picture No. 1

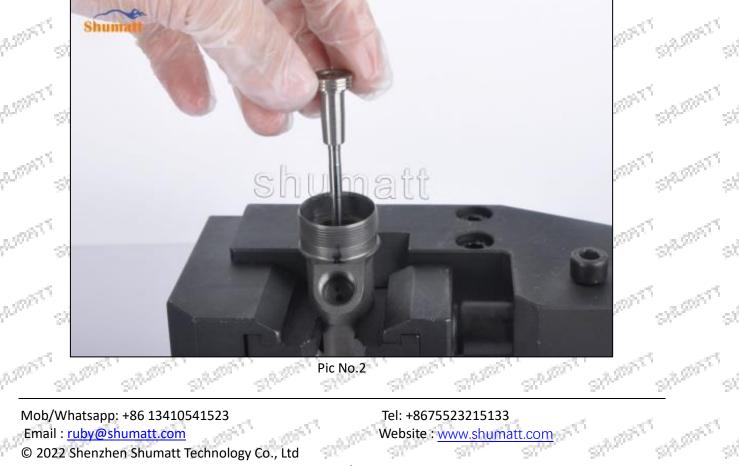
(2) Place the valve assembly into the injector and use the special tools in CRT029 to install the valve assembly in place as shown in picture No. 2 assembly in place, as shown in picture No. 2

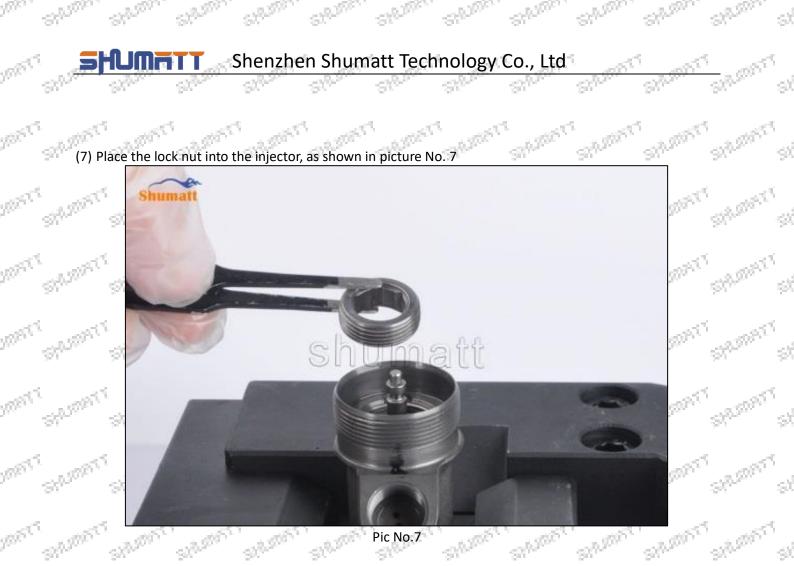
Pic No.8 SPERMIT

(8) Use the special tool for tightening the lock nut in CRT029 to tighten the lock nut to 65Nm, as shown in picture No. 8 e Co $e^{i\theta}$ $e^{i \theta_{i}}$

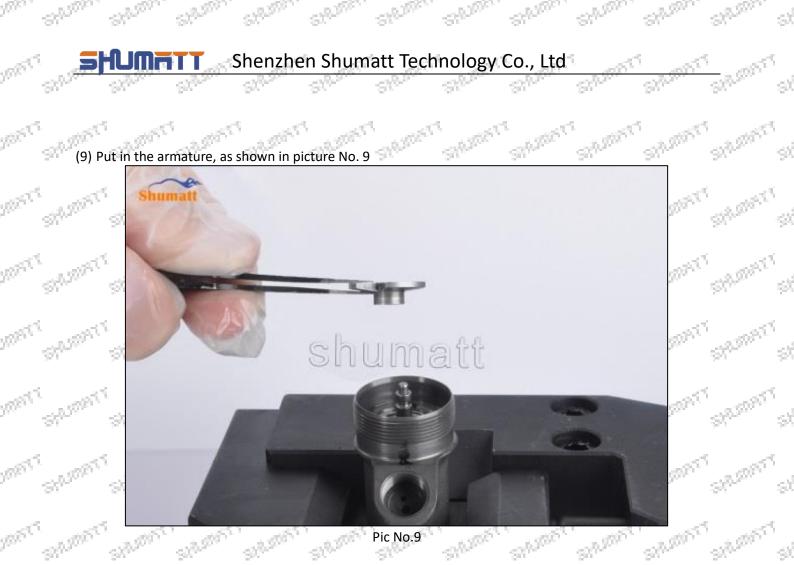
Pic No.10 SPERMENT SPRIMAT

(10) Press the armature plate downward so that the opening buffer stroke adjust washer can be stuck in the slot on the armature core, as shown in picture No. 10

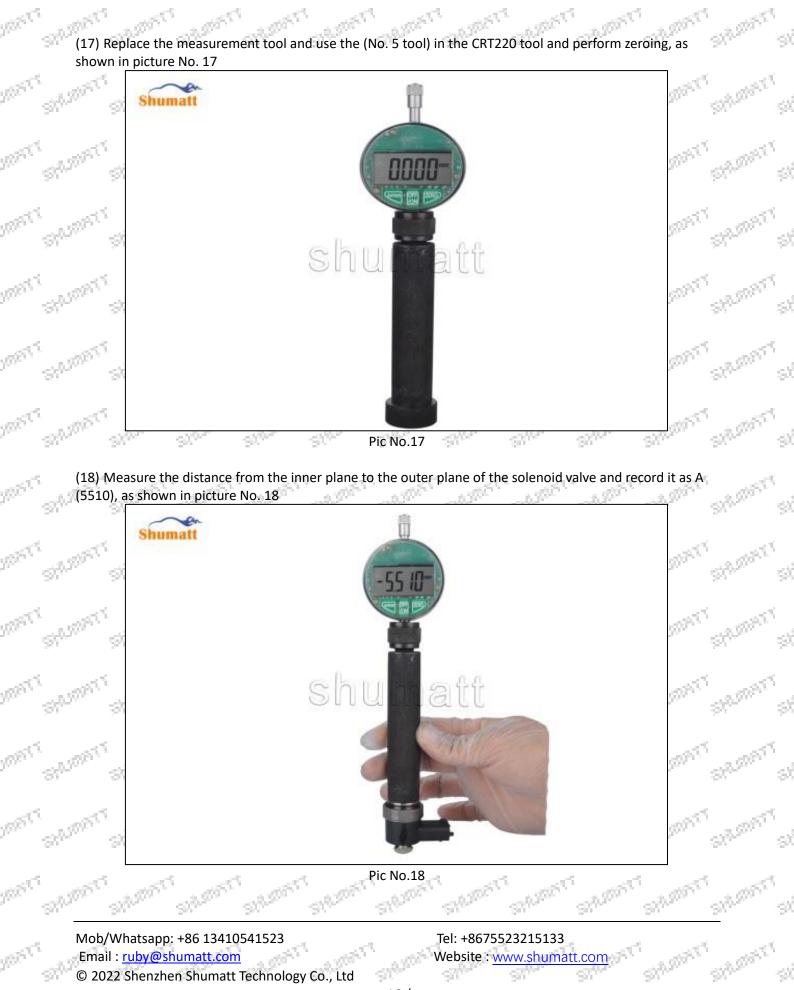
(20) Residual air gap = A data - B data. The value of the remaining air gap is 45-55Nm. If it is greater than the normal value, reduce the remaining air gap stroke adjust washer shim. If it is less than the normal value, thicken the remaining air gap stroke adjust washer shim, as shown in picture No. 20

thicken the remaining air gap stroke adjust washer shim, as shown in picture No. 20 Fire No.20 Mod/Whatsapp: +86 13410541523 Email: ruby@shumatt.com 0 2022 Shenzhen Shumatt Technology Co., ttd

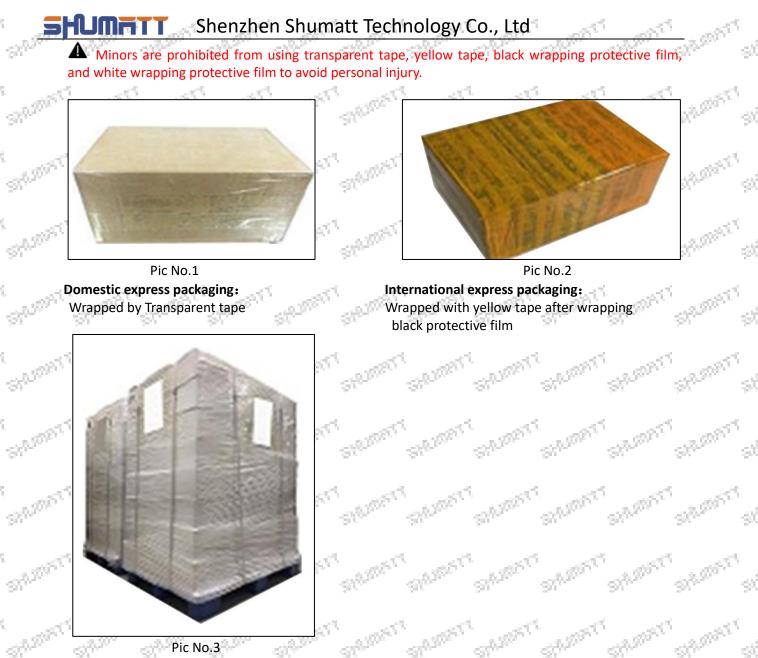
Pallet Shipping: Use pallet that meet export requirements, and use white wrapping protective film to wrap and bind with cable ties
